January 5, 2021

**SUBJECT: Christmas Day Explosion; Rapid Visual Inspection of Buildings  
2<sup>nd</sup> Avenue North, Buildings, Nashville, TN  
Project No: 20069**

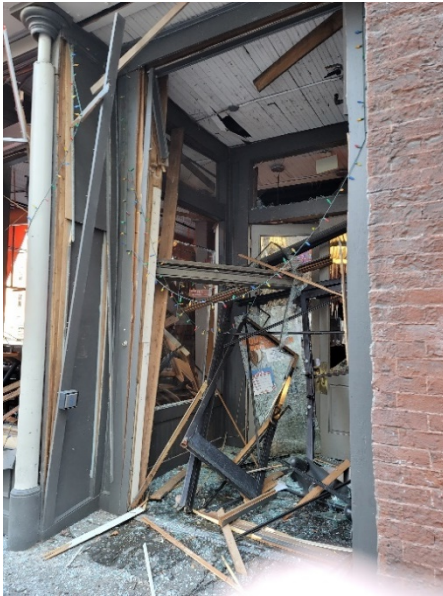
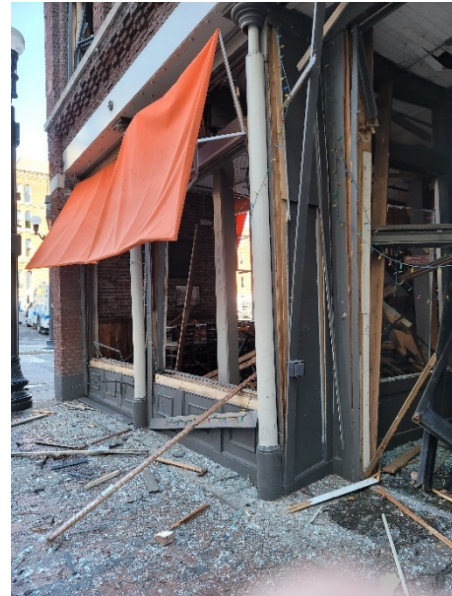
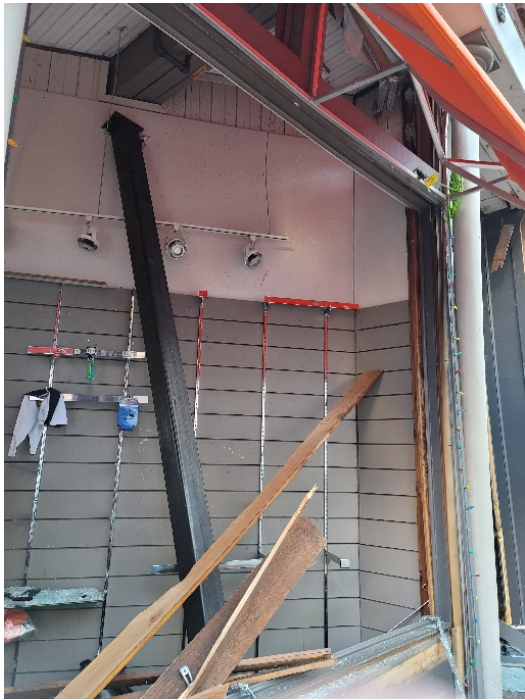
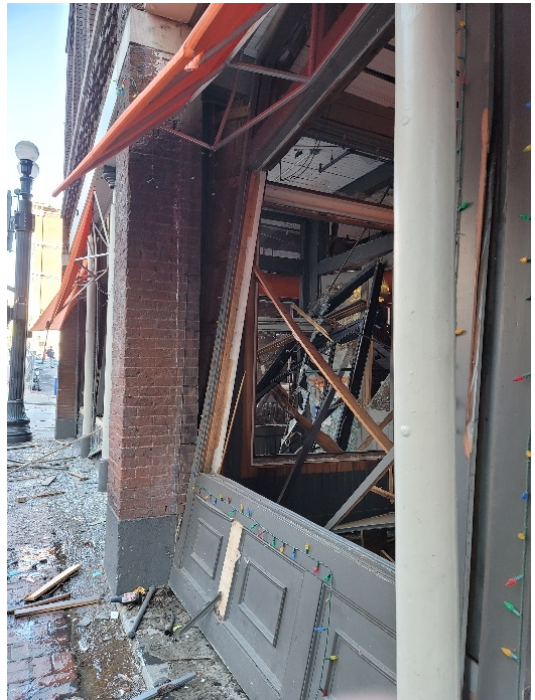
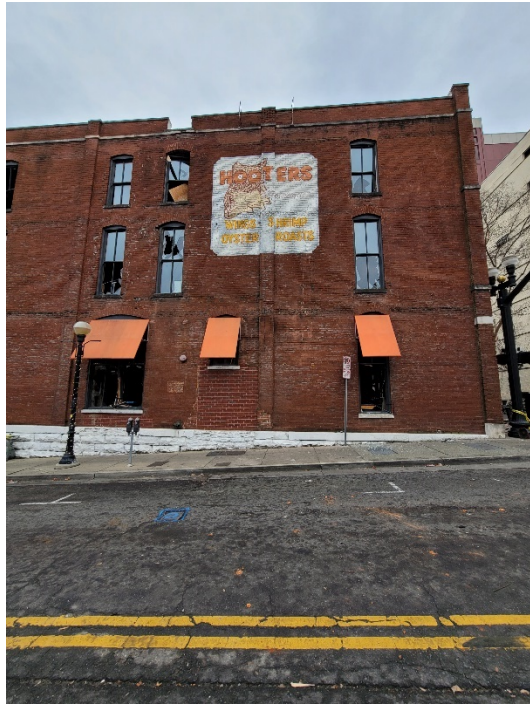
### 184 2<sup>nd</sup> Avenue North, Hooters

Structure is unreinforced masonry walls with wood floor & roof framing.  
Impact of the blast has caused extensive damage.  
Store front windows and casing collapsed / leaning into building.  
Roof and floor structure including beams, columns and rafters have been severely compromised.  
Many beams and rafters have failed.

#### **Visual Assessment: Structure in danger of Imminent Collapse**

It is our opinion that the structure is unstable. Front and perimeter walls should be shored prior to any clean-up work. Building should remain posted "**UNSAFE.**" Abundant caution should be exercised during any access inside the building. Only professional construction staff should be allowed. It is our opinion that the structural framing of the building will require substantial replacement and the walls will need to be tied to new framing and retrofitted.

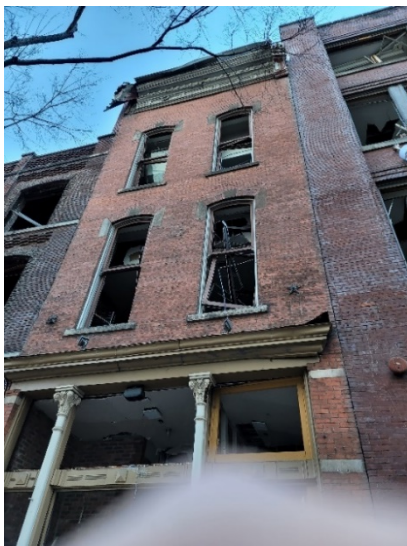
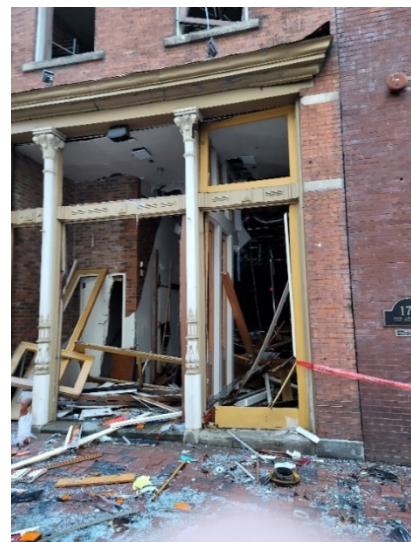
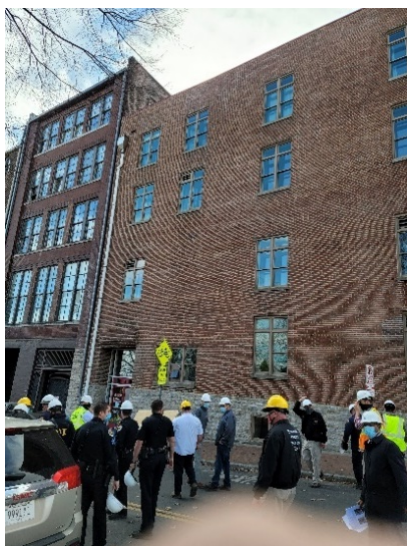
## 180 2nd Avenue North, "101 Church St" – Nashville Downtown Hostel

Structure is unreinforced masonry walls with wood floor & roof framing.  
Impact of the blast has caused extensive damage.  
Front entry door collapsed.  
High façade appears unsafe.  
Interior ceiling buckling – potential hazard.

### **Visual Assessment: Structure in danger of Imminent Collapse**

It is our opinion that the structure is unstable. Front and perimeter walls should be shored prior to any clean-up work. Building should remain posted "**Restricted Use.**" Abundant caution should be exercised during any access inside the building. Only professional construction staff should be allowed. It is our opinion that the structural framing and walls will require a thorough evaluation and rehabilitation.

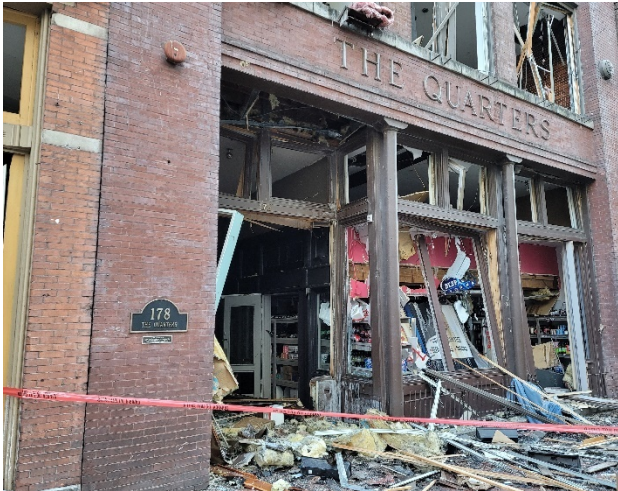
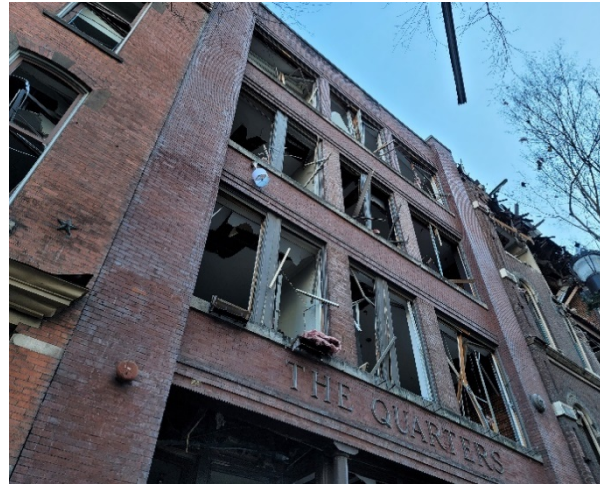
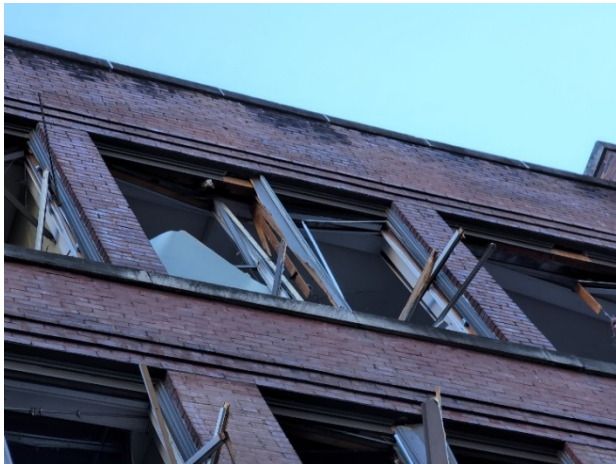
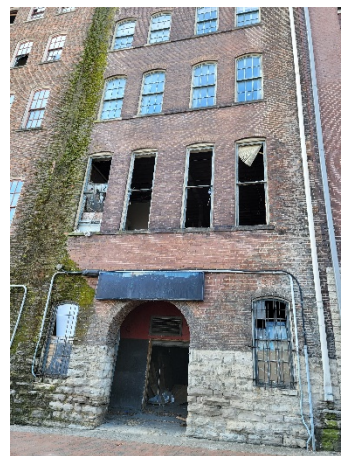
## 178 2nd Avenue North, The Quarters

Structure is unreinforced masonry walls with wood floor & roof framing.

Impact of the blast has caused extensive damage.

Store front and windows collapsed on each floor.

Parapet appears to have some rotation and bowing – a potential hazard to fall on someone standing below.

Ceiling damage on each floor.

It is likely given the conditions of the ceiling that some damage has occurred to the beams, rafters and columns in the structure. There is a high potential that some have failed.

### **Visual Assessment: Structure in danger of Imminent Collapse**

It is our opinion that the structure is unstable. Front and perimeter walls should be shored prior to any clean-up work. Building should remain posted “**UNSAFE.**” Abundant caution should be exercised during any access inside the building. Only professional construction staff should be allowed. It is our opinion that the structural framing of the building will require substantial replacement and the walls will need to be tied to new framing and retrofitted.

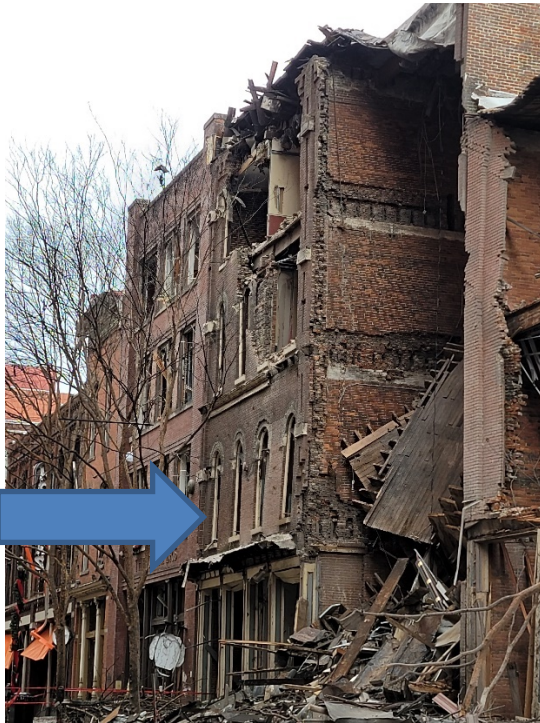
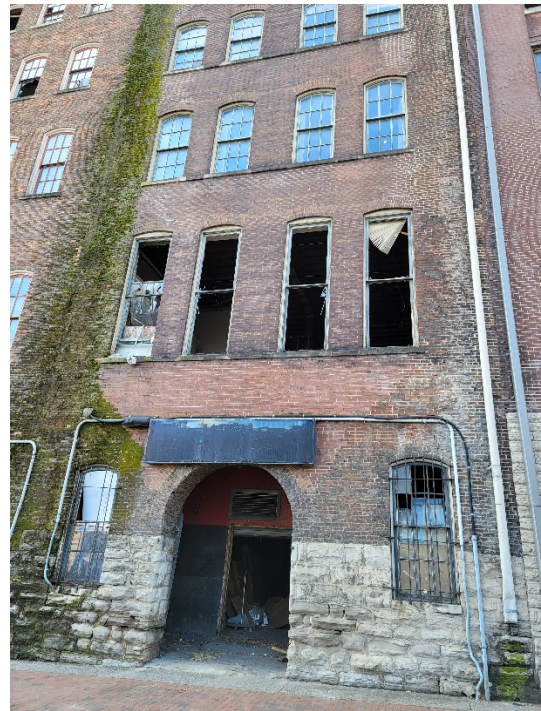
## 176 2<sup>nd</sup> Avenue North, Unnamed Building

Structure is unreinforced masonry walls with wood floor & roof framing.  
Impact of the blast has caused extensive damage.  
The store front has collapsed.  
The columns supporting the front façade above are displaced.  
The 3<sup>rd</sup> and 4<sup>th</sup> floors façade is partially or fully collapsed.

### **Visual Assessment: Collapsed (Structure in danger of further Imminent Collapse)**

It is our opinion that this building is uninhabitable and unsafe in the current condition. Demolition of the front façade and a significant portion of the structure is anticipated. Additional shoring of remaining unbraced masonry walls should be conducted. Given the condition of the building to the south there is a high potential for further collapse. Building should be posted "**UNSAFE.**" No personnel should be allowed into the building. It is our opinion that this building will be partially demolished and rebuilt.

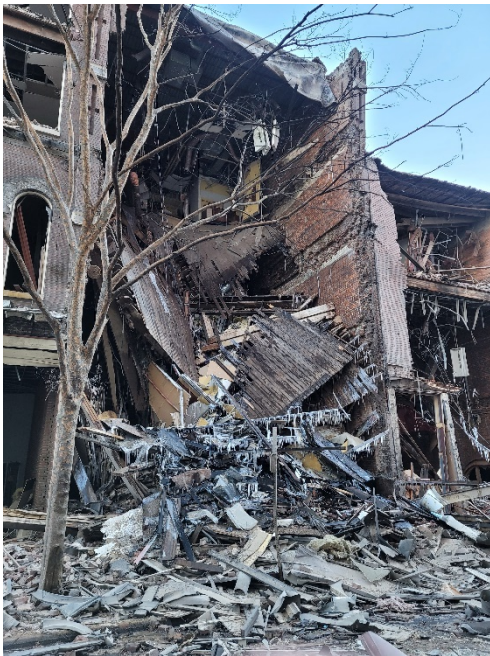
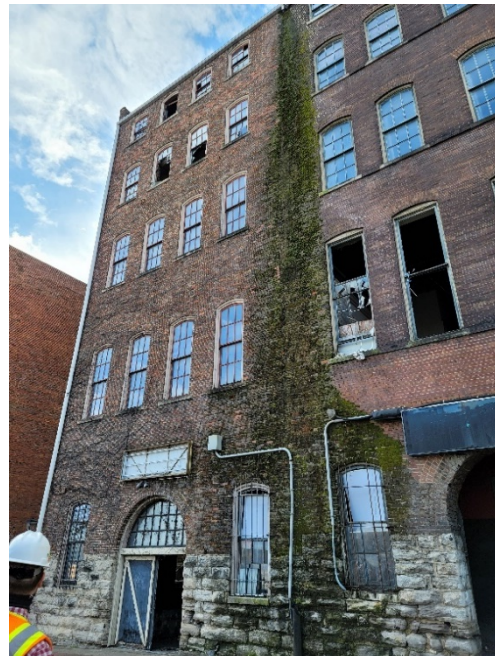
## 174 2<sup>nd</sup> Avenue North, Unnamed Building - 4 Stories

Structure is unreinforced masonry walls with wood floor & roof framing.

Impact of the blast has caused extensive damage.

Total collapse.

4<sup>th</sup> floor wall on south side of building leaning towards 172 2<sup>nd</sup> Avenue – collapse imminent.

### **Visual Assessment: Collapsed (Structure in danger of further Imminent Collapse)**

It is our opinion that this building is uninhabitable and unsafe in the current condition. Demolition of a significant portion of the building is anticipated. Additional shoring of remaining unbraced masonry walls between adjacent structures should be carried out as soon as it is safe to do so.

Building should be posted “**UNSAFE.**” No personnel should be allowed into the building. It is our opinion that a large portion of this building will be demolished and rebuilt.

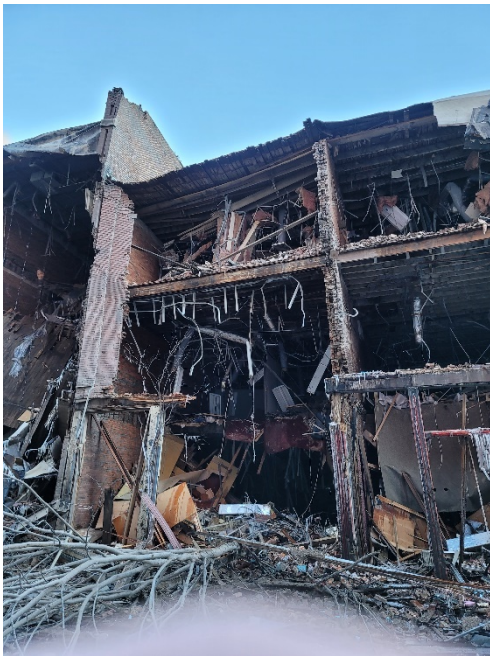
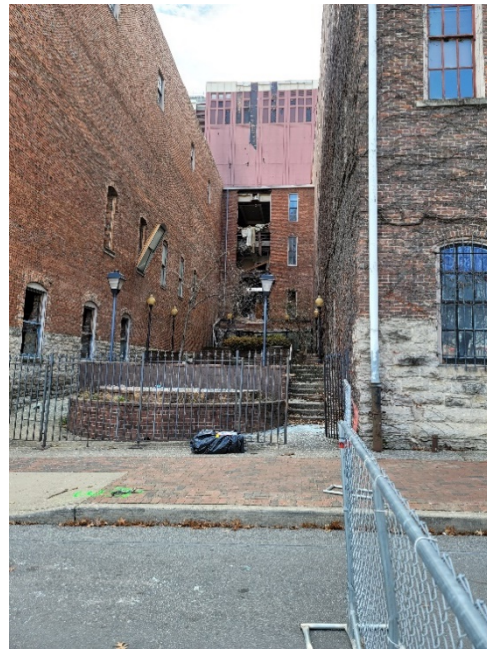
## 172 2<sup>nd</sup> Avenue North, Unnamed Building – 3 stories

Structure is unreinforced masonry walls with wood floor & roof framing.  
Impact of the blast has caused extensive damage.  
Total collapse.

### **Visual Assessment: Collapsed (Structure in danger of further Imminent Collapse)**

It is our opinion that this building is uninhabitable and unsafe in the current condition. Demolition of a significant portion of the building is anticipated. Additional shoring of remaining unbraced masonry walls between adjacent structures should be carried out as soon as it is safe to do so. Building should be posted "**UNSAFE.**" No personnel should be allowed into the building. It is our opinion that a large portion of this building will be demolished and rebuilt.

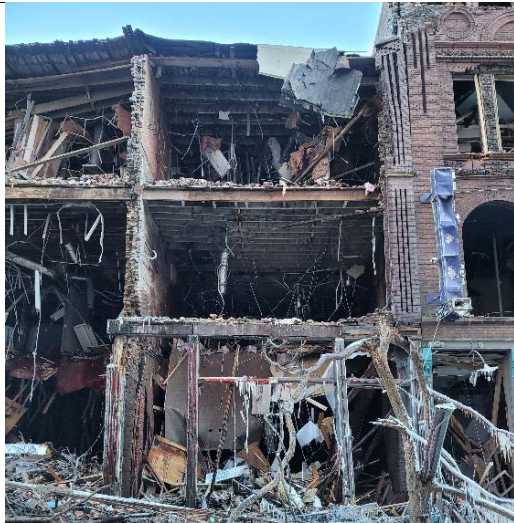
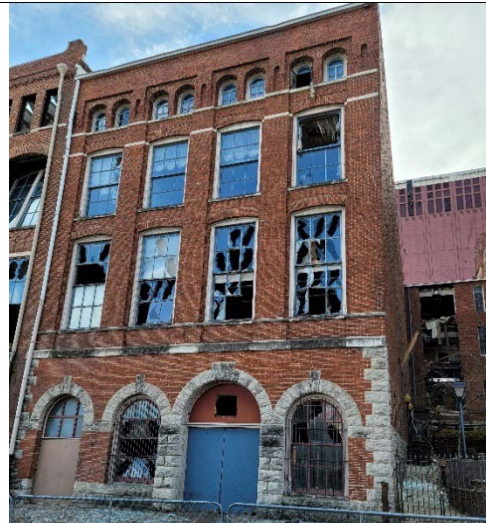
## 170 2<sup>nd</sup> Avenue North, Unnamed Building – 3 stories

Structure is unreinforced masonry walls with wood floor & roof framing.  
Impact of the blast has caused extensive damage.  
Partial collapse.

### **Visual Assessment: Collapsed (Structure in danger of further Imminent Collapse)**

It is our opinion that this building is uninhabitable and unsafe in the current condition. Demolition of a significant portion of the building is anticipated. Additional shoring of remaining unbraced masonry walls between adjacent structures should be carried out as soon as it is safe to do so. Building should be posted "**UNSAFE.**" No personnel should be allowed into the building. It is our opinion that a large portion of this building will be demolished and rebuilt.

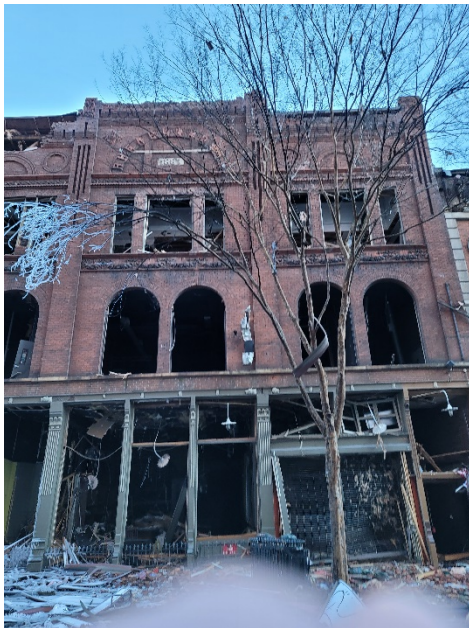
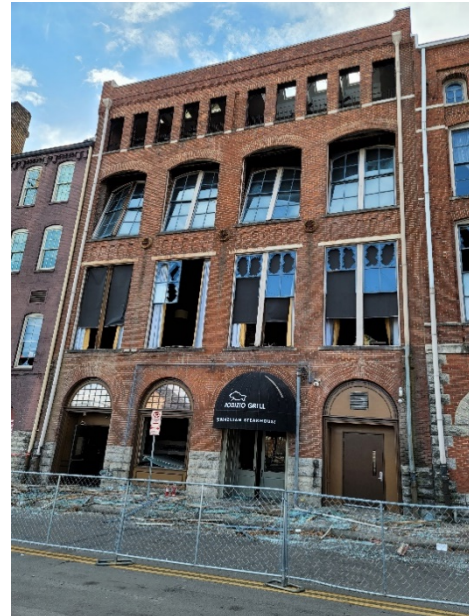
**168 2<sup>nd</sup> Avenue North, Rhea Building**  
**Laser Quest, Rodizio Grill, Melting Pot**

Structure is unreinforced masonry walls with wood floor & roof framing.

Impact of the blast has caused extensive damage.

Left side of building – A portion of the parapet has collapsed, brick façade collapse around windows.

Left 3<sup>rd</sup> floor window brick lintel unsupported.

Significant amount of structure displaced on first floor.

First floor façade support displaced.

**Visual Assessment: Collapsed (Structure in danger of further Imminent Collapse)**

It is our opinion that this building is uninhabitable and unsafe in the current condition. Demolition of a significant portion of the building is anticipated. Additional shoring of remaining unbraced masonry walls between adjacent structures should be carried out as soon as it is safe to do so.

Building should be posted “**UNSAFE.**” No personnel should be allowed into the building. It is our opinion that a large portion of this building will be demolished and rebuilt.

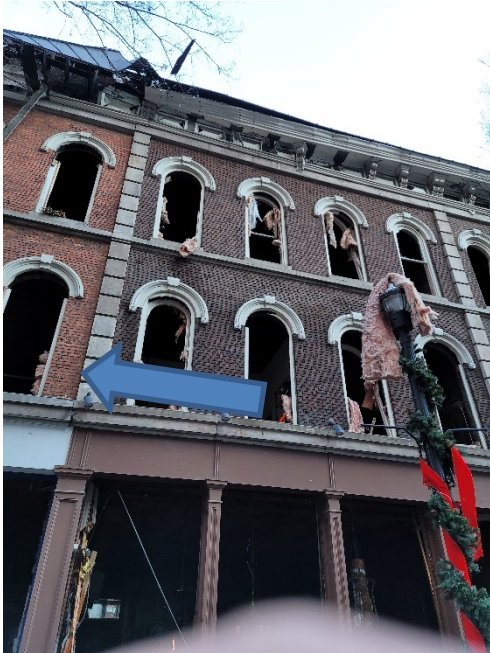
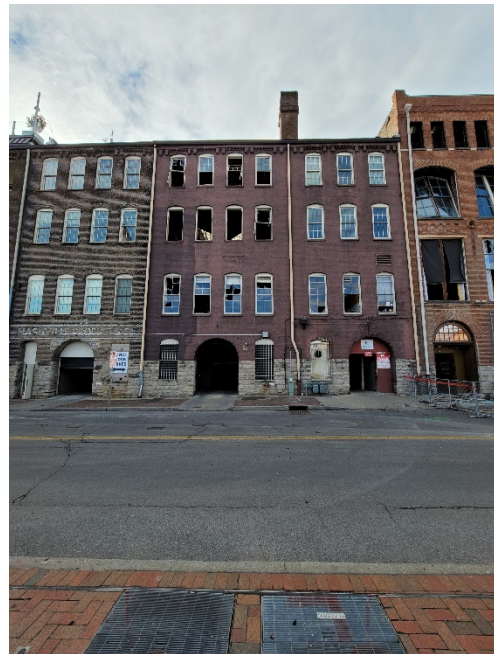
## 164 2<sup>nd</sup> Avenue North, Unnamed Building

Structure is unreinforced masonry walls with wood floor & roof framing.  
Impact of the blast has caused extensive damage.  
Store front and windows collapsed on each floor.  
The façade is bowing in on the 3<sup>rd</sup> floor.

### **Visual Assessment: Structure in danger of Imminent Collapse**

It is our opinion that the structure is unstable. Front and perimeter walls should be shored prior to any clean-up work. Building should remain posted "**UNSAFE.**" Abundant caution should be exercised during any access inside the building. Only professional construction staff should be allowed. It is our opinion that the structural framing of the building will require substantial replacement and the walls will need to be tied to new framing and retrofitted.

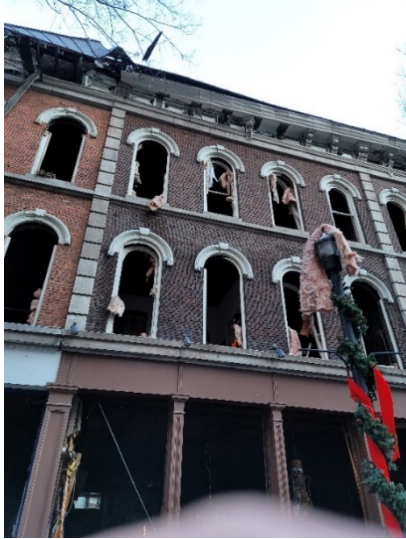
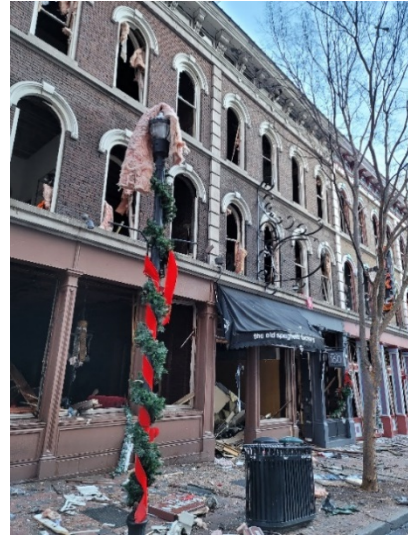
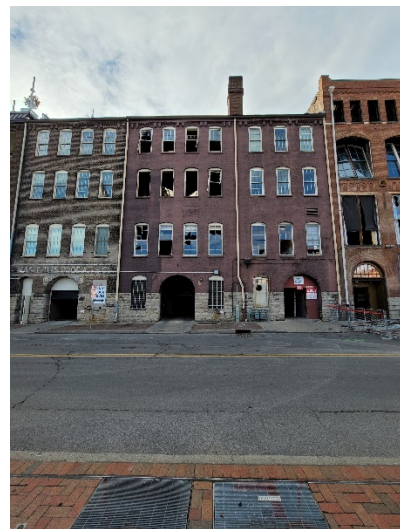
## 160 2<sup>nd</sup> Avenue North, Spaghetti Factory, 160 Lofts

North end of parapet overhang appears questionable.  
Façade appears intact.

### **Visual Assessment: Structure in danger of Imminent Collapse**

It is our opinion that the structure is unstable. Front and perimeter walls should be shored prior to any clean-up work. Building should remain posted "**UNSAFE.**" Abundant caution should be exercised during any access inside the building. Only professional construction staff should be allowed. It is our opinion that the structural framing of the building will require substantial replacement and the walls will need to be tied to new framing and retrofitted.

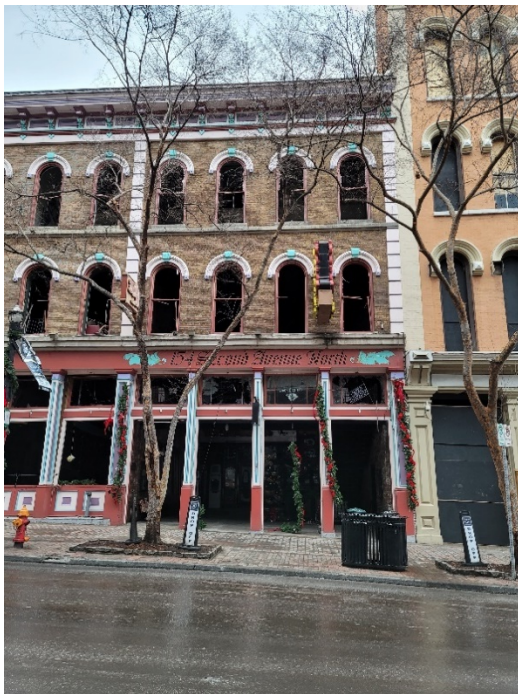
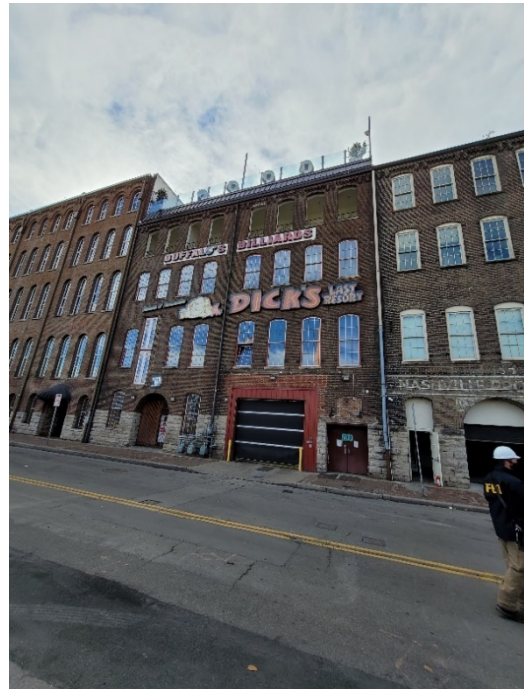
## **154 2<sup>nd</sup> Avenue North, Buffalo Billiards, Dick's, Last Resort, 154 Luxury Hotel**

The front façade appears unremarkable.

There appear to be some cracks in the left and right walls of the breezeway on the street level on Second Avenue side.

There appear to be cracks on the left and right masonry walls of buffalo billiards that were reportedly there prior to the blast but appear a little wider.

The façade bracing structure appears to have shifted slightly south when viewed from the interior of the breeze way.

On the front portions of the building there are a number of roof joist that appear cracked, damaged, or failed. Most of the damage to the roof structure appears to be limited to the suites with Second Avenue frontage.

There appears to be a few punctures in the roof membrane.

### **Visual Assessment: Structure in danger of Imminent Collapse**

It is our opinion that the structure is unstable. Front and perimeter walls should be shored prior to any clean-up work. Building should remain posted "**UNSAFE.**" Abundant caution should be exercised during any access inside the building. Only professional construction staff should be allowed. It is our opinion that the structural framing of the building will require substantial replacement and the walls will need to be tied to new framing and retrofitted.

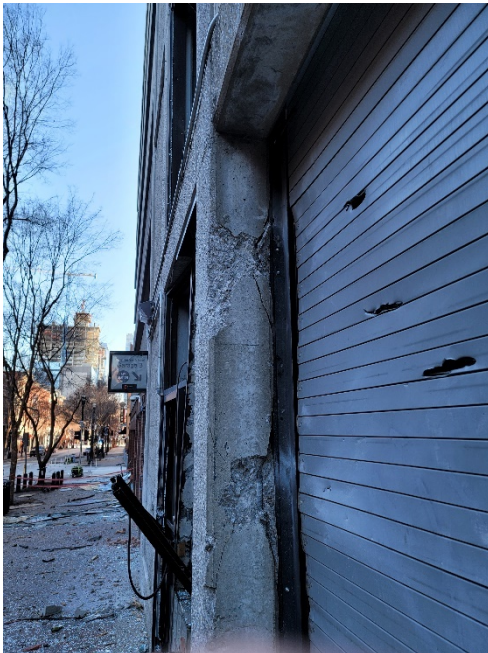
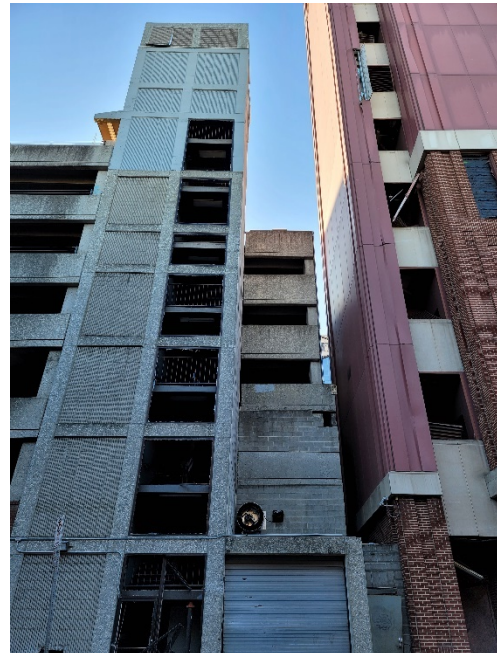
## Commerce St Garage

Veneer damage at elevator shaft – considerably sized hole.

Concrete column – impact damage loss of section and exposed rebar in two locations on north face.

Low one-story concrete masonry unit (CMU) block wall and pedestrian door damaged.

Third floor CMU block displaced out from concrete structure. Some blocks complete displaced.

Concrete structure of stair tower appears to lean above top parking deck – potentially pour initial construction but also could be from blast.

Pedestrian door on level 6 to north east stair tower has a considerable trip hazard. Full stair tower needs detailed investigation.

It is our opinion that the primary garage structure appears to be stable. However, the north east stair tower does not appear to be questionable. The stair tower should be posted “**RESTRICTED USE**” pending further investigation. However, as the damage is extensive, abundant caution should be exercised during any access inside the northeast stair tower. Prior to use of the garage the structural damage reported above should be repaired. It is our opinion that this structure can be rehabilitated in-place.
